CASE STUDY

Snows Farm Nature Reserve

**STROUD RURAL
SUSTAINABLE
DRAINAGE PROJECT**

NATURAL FLOOD MANAGEMENT
IN THE STROUD VALLEYS

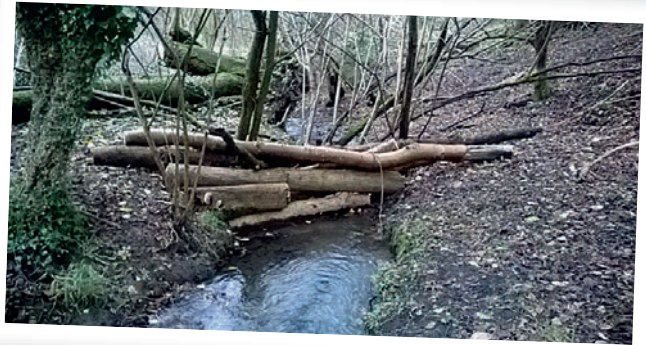
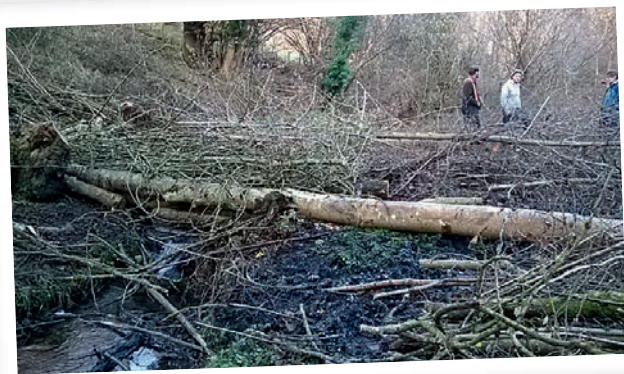
The aim of the project was to slow down the flow of flood peaks into the valley and divert water onto small floodplains. Fifteen leaky dams constructed from tree trunks and branches were installed to create a partial blockage of the stream. In low flows, water can pass freely under the structures but, at high flows after very heavy rain, some water will be attenuated behind the leaky dam.

The stream-side woodland is mostly alder, ash and hazel coppice. This has been unmanaged for approximately 30 years so a considerable amount of coppicing and clearing was required before workers could fell the larger trees that were needed for the leaky dams. The banks are too steep for machine access so all of the work was carried out by a two-man felling team. Felled trees were manipulated into place using a Tirfor winch. All of the tree trunks were then pinned in place using 1.2m reinforcing steel bars, through holes drilled with a petrol auger, to clamp the material together and secure the structures into the ground. The timber was donated to the project by the landowner.
